**Flood Control Project Maintenance  
Levee Inspections**

**Fall 2016 Levee Maintenance Deficiency Summary Report**

**Levee District No. 0001 (Sutter County)**

**Levee Inspection Report By Mile - Fall 2016**

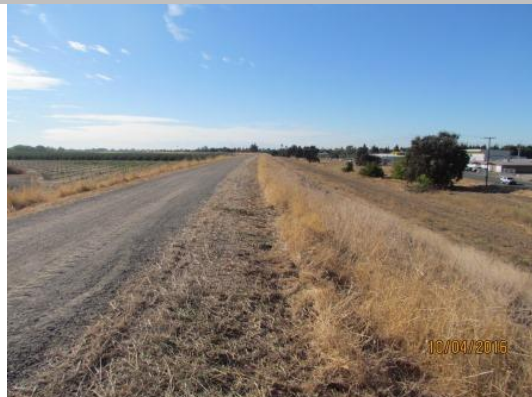
Photo 1 of 2 : FA\_2016\_LD0001S\_433\_30\_20161007\_00059.jpg

LM Start	0.01	Rating **	M	Issue No.	30
LM End	16.09	Issue Type +	Ma	Location *	LS
Category	Earthen Levee			GPS Latitude/Longitude	
				Start	End
Item	Vegetation			38.951109 °	39.168577 °
				-121.585711 °	-121.622691 °
DWR ID	DWR_LD0001S_01_f_2016_30				
Comment Code					
V1 : Control annual grass and weeds on the levee slopes and easements.					
Inspector Comment					
Annual grasses need to be maintained. Fall 2016.

View of annual grasses need to be maintained. Fall 2016.

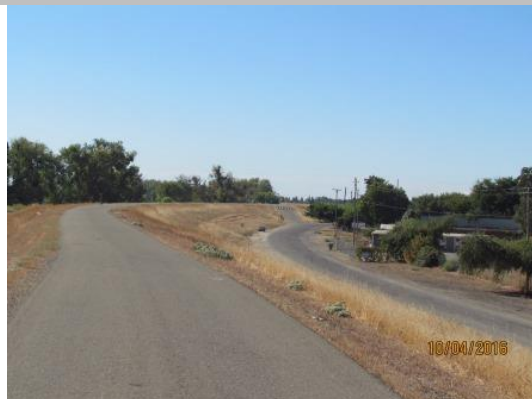
Photo 2 of 2 : FA\_2016\_LD0001S\_433\_30\_20161007\_00061.jpg

Second view of annual grasses need to be maintained. Fall 2016.

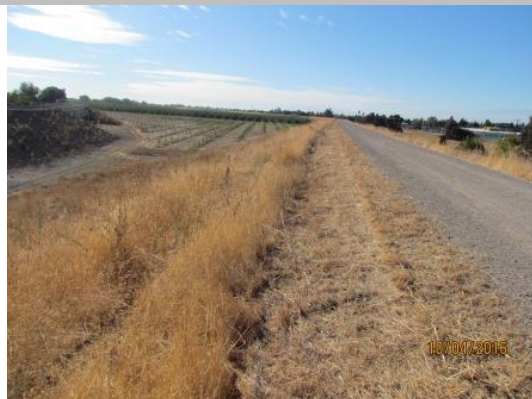
Photo 1 of 2 : FA\_2016\_LD0001S\_433\_31\_20161007\_00062.jpg

LM Start	0.01	Rating **	M	Issue No.	31
LM End	16.09	Issue Type +	Ma	Location *	WS
Category	Earthen Levee			GPS Latitude/Longitude	
				Start	End
Item	Vegetation			38.951109 °	39.168577 °
				-121.585711 °	-121.622691 °
DWR ID	DWR_LD0001S_01_f _ 2016_31				
Comment Code					
V1 : Control annual grass and weeds on the levee slopes and easements.					
Inspector Comment					
Annual grasses need to be maintained. Fall 2016.

View of annual grasses need to be maintained. Fall 2016.

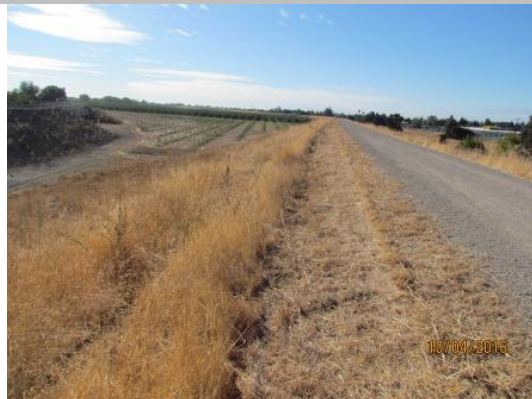
Photo 2 of 2 : FA\_2016\_LD0001S\_433\_31\_20161007\_00063.jpg

LM Start	0.01	Rating **	M	Issue No.	31 (cont)	
LM End	16.09	Issue Type +	Ma	Location *	WS	
Category	Earthen Levee			GPS Latitude/Longitude		
				Start		End
Item	Vegetation			38.951109 °		39.168577 °
				-121.585711 °		-121.622691 °
DWR ID	DWR_LD0001S_01_f _ 2016_31					
Comment Code						
V1 : Control annual grass and weeds on the levee slopes and easements.						
Inspector Comment						
Annual grasses need to be maintained. Fall 2016.

Second view of annual grasses need to be maintained. Fall 2016.

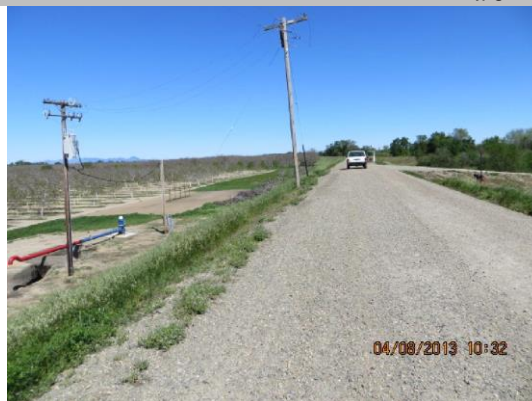
Photo 1 of 2 : UCIP\_FA\_2016\_41624\_18769.jpg

LM Start	0.36	Rating **	M	Issue No.	497	
LM End	0.36	Issue Type +	En	Location *	LS	
Category	Supplemental			GPS Latitude/Longitude		
				Start		End
Item	DWR UCIP Field Study			38.956192 °		38.956192 °
				-121.585510 °		-121.585510 °
DWR ID						
Comment Code						
Inspector Comment						
FS_ID:41624 DS_ID:18653 EP_NO: 4667 Repair Type: Non-Urgent Crossing Status: Found UCIP Comments: Abandoned crossing. Concrete box on both sides found. Pipe remainings are found on WS. FIELD_STRUCT_DESC: *ABANDONED* Concrete box on both sides found. Pipe remainings are found on WS after the removal of 40 feet of 36" steel pipe from a spur levee and 20 feet of 36" steel pipe from the landside slope of Feather River Levee. Pipe depth 10.0 ft below crown. Application No. 4667, 1964.O&M Manual Sac 144, August 1955, Revision Year 2011. FS Date: 4/12/2013

Crown view- overview of both sides of the levee

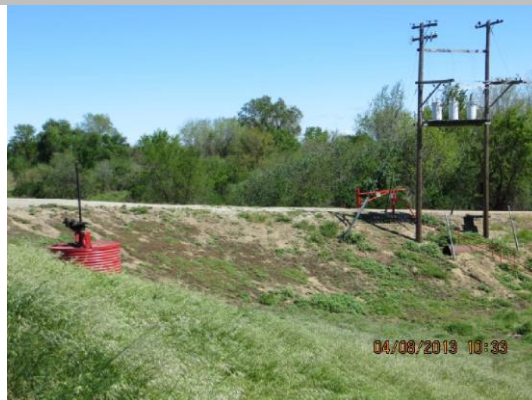
Photo 2 of 2 : UCIP\_FA\_2016\_41624\_18768.jpg

WS- abandoned pipe near power pole (right)

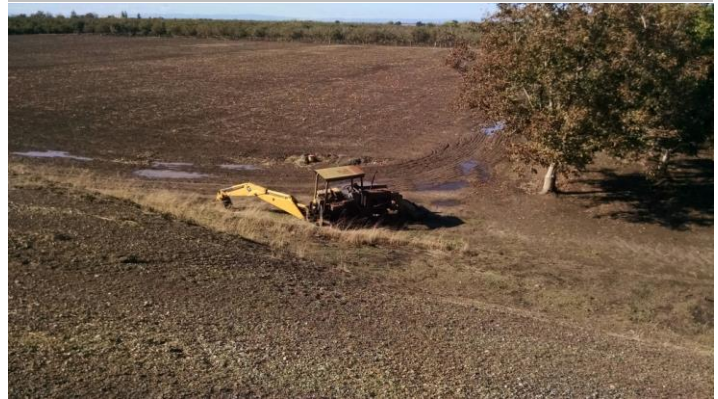
Photo 1 of 2 : FA\_2016\_LD0001S\_433\_13\_20160906\_00004.jpg

LM Start	0.68	Rating **	M	Issue No.	13
LM End	0.68	Issue Type +	En	Location *	LS
Category	Earthen Levee			GPS Latitude/Longitude	
				Start	End
Item	Encroachments			38.960772 °	38.960772 °
				-121.585943 °	-121.585943 °
DWR ID	DWR_LD0001S_01_f _ 2015_13				
Comment Code					
EQ : Equipment					
Inspector Comment					
Backhoe still at toe of landside levee. Fall 2016

This picture was from Fall 2015 Inspection but the backhoe is still there and the picture is the same for Spring of 2016. The backhoe was located on the landside toe of the levee.

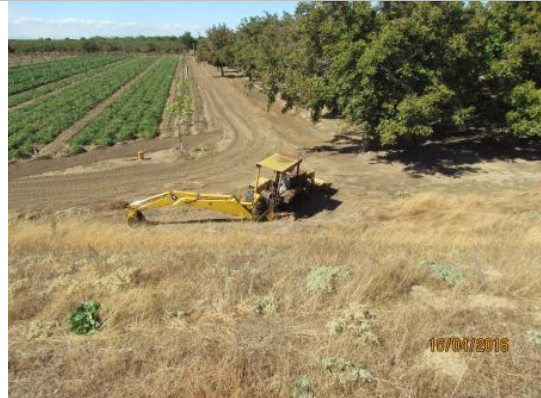
Photo 2 of 2 : FA\_2016\_LD0001S\_433\_13\_20161007\_00089.jpg

Backhoe is still there for Fall of 2016. The backhoe is on the landside toe of the levee.

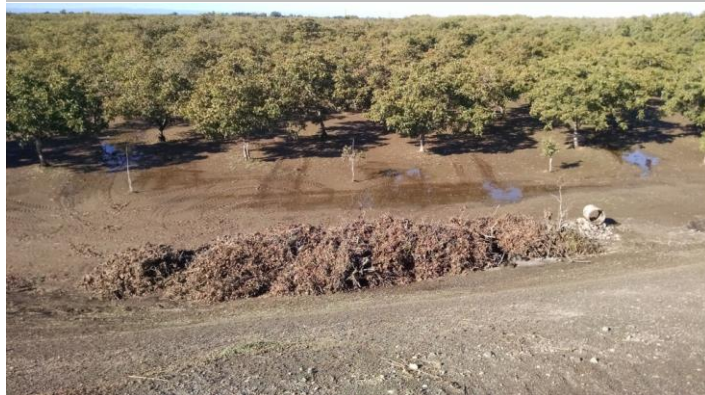
Photo 1 of 2 : FA\_2016\_LD0001S\_433\_14\_20160906\_00005.jpg

LM Start	1.12	Rating **	M	Issue No.	14
LM End	1.12	Issue Type +	En	Location *	LS
Category	Earthen Levee			GPS Latitude/Longitude	
				Start	End
Item	Encroachments			38.966868 °	38.966868 °
				-121.587230 °	-121.587230 °
DWR ID	DWR_LD0001S_01_f_2015_14				
Comment Code					
PR : Prunings					
Inspector Comment					
Remove pruning's from levee toe. Fall 2016.

Prunings on the landside toe are blocking visibility. Spring 2016.

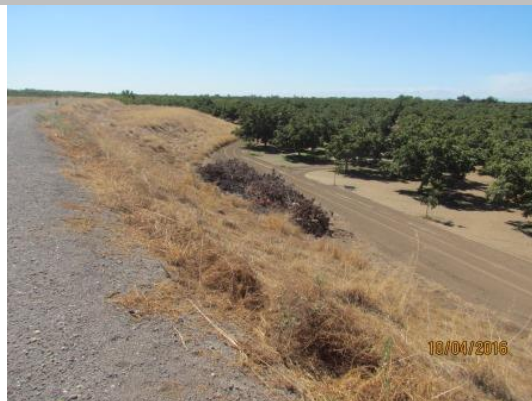
Photo 2 of 2 : FA\_2016\_LD0001S\_433\_14\_20161007\_00088.jpg

Prunings on the landside toe are blocking visibility. Fall 2016.

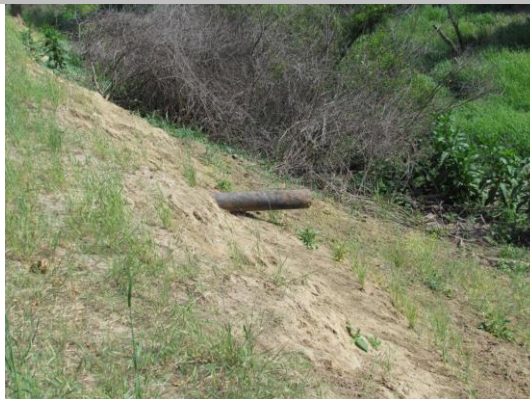
Photo 1 of 2 : UCIP\_FA\_2016\_50641\_75107.jpg

FS\_ID:50641  
DS\_ID:17917  
EP\_NO: N/A  
Repair Type: Urgent  
Crossing Status: Found  
UCIP Comments: 07/20/2016 Same as previous comment, although pipe is open on the waterside (WS) and capped on the LS. Note that this section of levee will likely be reconstructed as part of Project Area A of the Feather River West Levee Project (Star Bend to Sutter Bypass). (K. Fazel - UCIP)05/23/2016 Needs proper abandonment; pipe open on both ends (courtesy of Sterling York, DWR Inspector). (K. Fazel - UCIP)  
FIELD\_STRUCT\_DESC: \*ABANDONED\* 8-inch steel pipe of an unknown purpose through the levee, 4.6 feet below the crown. Siphon breaker in a 24-inch corrugated metal riser on the landside (LS) shoulder, not found in 2016. [Additional Reference(s): DWR Levee Log, 2005. USACE Sacramento O&M Manual 144, August 1955. As-Built Drawing No. 4-4-205-1 (Station 657+00)].  
FS Date: 7/20/2016

Pipe visible on WS slope. Photo courtesy of Sterling York, DWR Inspector.

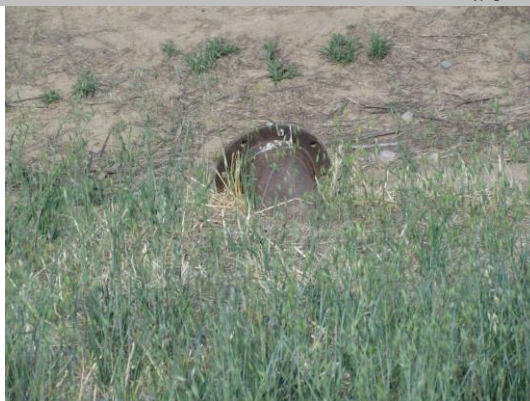
Photo 2 of 2 : UCIP\_FA\_2016\_50641\_75108.jpg

Pipe open on LS end. Photo courtesy of Sterling York, DWR Inspector.

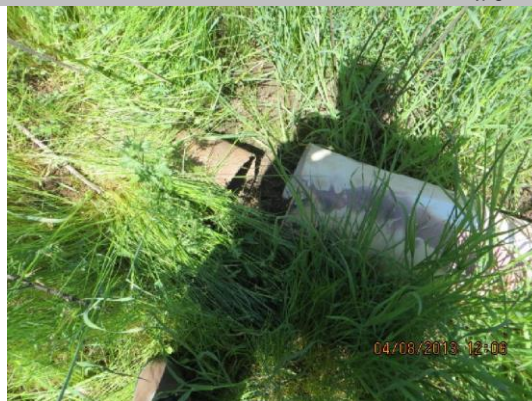
Photo 1 of 2 : UCIP\_FA\_2016\_11383\_18782.jpg

LM Start	2.21	Rating **	M	Issue No.	491
LM End	2.21	Issue Type +	En	Location *	LS
Category	Supplemental			GPS Latitude/Longitude	
				Start	End
Item	DWR UCIP Field Study			38.982135 °	38.982135 °
				-121.591974 °	-121.591974 °
DWR ID					
Comment Code					
Inspector Comment					
FS_ID:11383 DS_ID:17915 EP_NO: N/A Repair Type: Non-Urgent Crossing Status: Found UCIP Comments: Siphon breaker cap missing. Sump pump and gate valve at landward toe not found may be due to dense vegetation. FIELD_STRUCT_DESC: A 8-inch steel drainage pipe through levee, 4.6-feet below the crown. Siphon breaker in corrugated metal riser on landward slope.O&M Manual Sac 144, August 1955, Revision Year 2011. FS Date: 4/12/2013

WS- 8-inch steel pipe and disconnected pvc pipe on levee slope

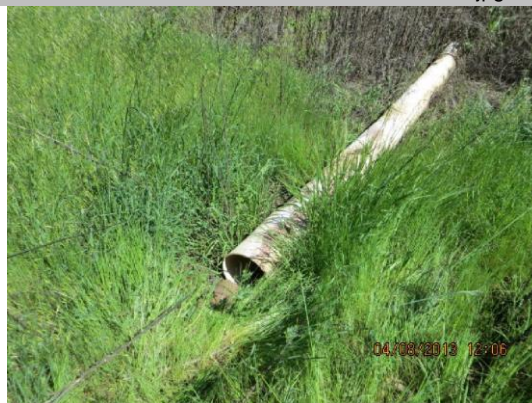
Photo 2 of 2 : UCIP\_FA\_2016\_11383\_18781.jpg

WS-a disconnected pvc pipe on levee slope

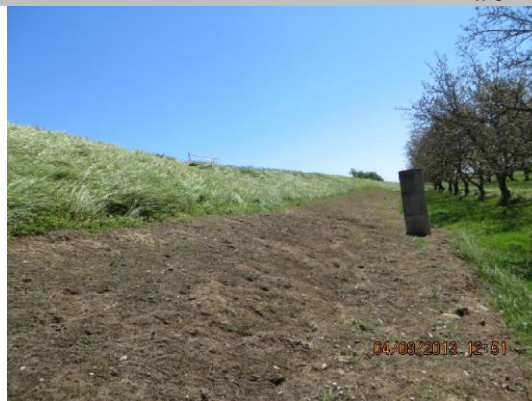
Photo 1 of 2 : UCIP\_FA\_2016\_41787\_18793.jpg

LM Start	2.42	Rating **	M	Issue No.	499
LM End	2.42	Issue Type +	En	Location *	LS
Category	Supplemental			GPS Latitude/Longitude	
				Start	End
Item	DWR UCIP Field Study			38.985223 °	38.985223 °
				-121.591922 °	-121.591922 °
DWR ID					
Comment Code					
Inspector Comment					
FS_ID:41787					
DS_ID:18667					
EP_NO: N/A					
Repair Type: Non-Urgent					
Crossing Status: Found					
UCIP Comments: Pipe appears to be abandoned and should be verified as having been done so properly. - concrete standpipe with 10-inch steel pipe.- concrete wing wall- no pipe- abandoned structure- a pump found on other side of the levee (WS) but not sure whether it is associated with this crossing.					
FIELD_STRUCT_DESC: *ABANDONED* 24" pipe under landside approach and install 10-inch corrugated iron pipe under landside approach(culvert).					
Not found in O&M Manual.					
FS Date: 4/12/2013

LS- overview of landside with concrete standpipe

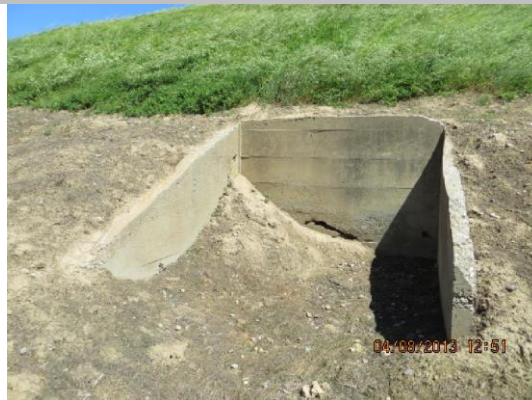
Photo 2 of 2 : UCIP\_FA\_2016\_41787\_18792.jpg

LS- abandoned wing wall- no pipe

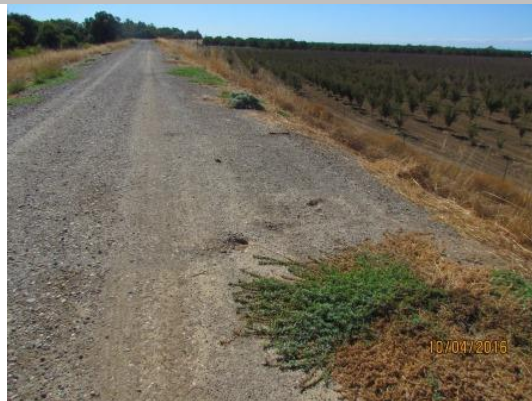
Photo 1 of 1 : FA\_2016\_LD0001S\_433\_17\_20161007\_00086.jpg

View of rodent holes on the landside crown and slope. Fall 2016.

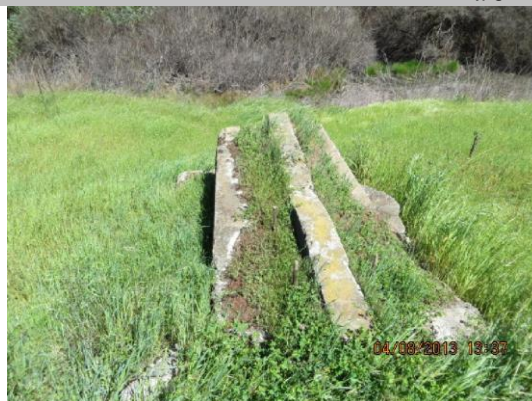
Photo 1 of 2 : UCIP\_FA\_2016\_41348\_18882.jpg

FS\_ID:41348  
DS\_ID:17918  
EP\_NO: N/A  
Repair Type: Non-Urgent  
Crossing Status: Indicator Found  
UCIP Comments: Only an abandoned steel structure on water and a concrete structure on WS Levee slope found. Need to verify pipe was properly abandoned.  
FIELD\_STRUCT\_DESC: \*ABANDONED\* steel 8-inch drainpipe through levee, 4.1 feet below crown. Siphon breaker on landward slope. Butterfly shutoff valve on landward slope, concrete stand pipe and pump at toe of landward slope. Discharges into borrow pit on waterward side.  
O&M Manual Sac 144, August 1955, Revision Year 2011.  
FS Date: 4/8/2013

WS- abandoned concrete structure on levee slope

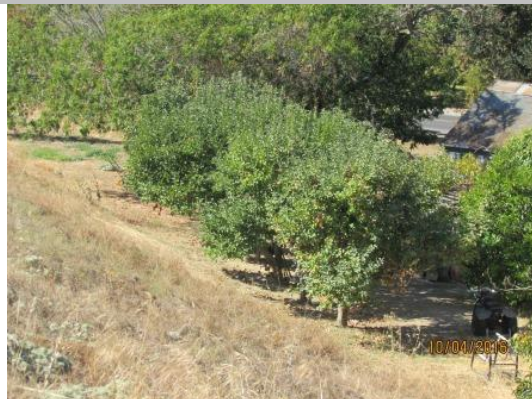
Photo 1 of 1 : FA\_2016\_LD0001S\_433\_489\_20161007\_00083.jpg

View of trees on the landside of the levee that have been trimmed up. Fall 2016.

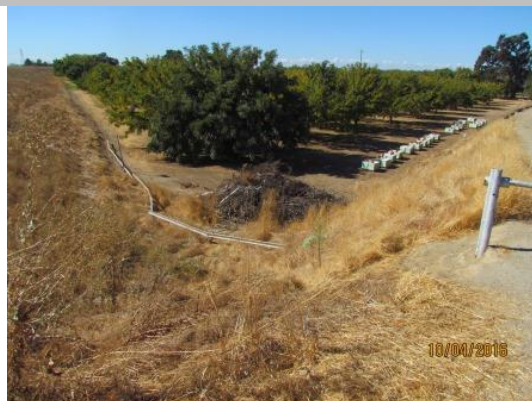
Photo 1 of 1 : FA\_2016\_LD0001S\_433\_23\_20161007\_00082.jpg

LM Start	9.35	Rating **	M	Issue No.	23
LM End	9.35	Issue Type +	En	Location *	LS
Category	Earthen Levee			GPS Latitude/Longitude	
				Start	End
Item	Encroachments			39.079026 °	39.079026 °
				-121.604386 °	-121.604386 °
DWR ID	DWR_LD0001S_01_f _ 2015_23				
Comment Code					
PR : Prunings					
Inspector Comment					
Tree trimmings at landside toe need removal that are within 10' of the toe.

View of pruning's on the landside levee toe looking downstream. Fall 2016.

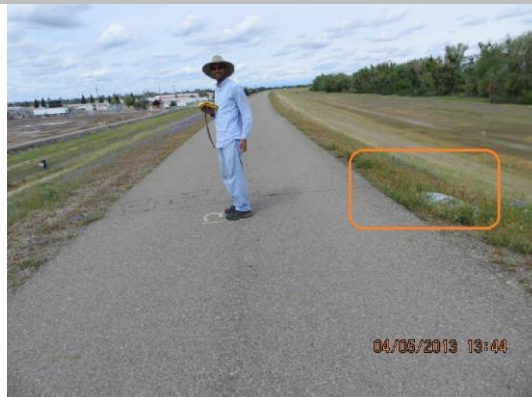
Photo 1 of 2 : UCIP\_FA\_2016\_50675\_19462.jpg

LM Start	11.39	Rating **	M	Issue No.	501
LM End	11.39	Issue Type +	En	Location *	LS
Category	Supplemental			GPS Latitude/Longitude	
				Start	End
Item	DWR UCIP Field Study			39.106261 °	39.106261 °
				-121.607535 °	-121.607535 °
DWR ID					
Comment Code					
Inspector Comment					
FS_ID:50675 DS_ID:18879 EP_NO: N/A Repair Type: Non-Urgent Crossing Status: Not Found UCIP Comments: 07/20/2016 Pipe and pump station removed as part of the Feather River West Levee Project. (K. Fazel - UCIP)04/05/2013 Road pavement cracked along pipe line, needs more investigation. (P. Amatya - DWR) FIELD_STRUCT_DESC: *REMOVED* 2 of 2. A 16-inch pipe (of 6-inch and 16-inch-pipes) through levee, 6.0 feet below crown. Flap gates on waterward end. Siphon breakers in corrugated metal pipe risers on waterward shoulder. Pump house at landward toe. FS Date: 7/20/2016

Levee crown overview- siphon breaker on right

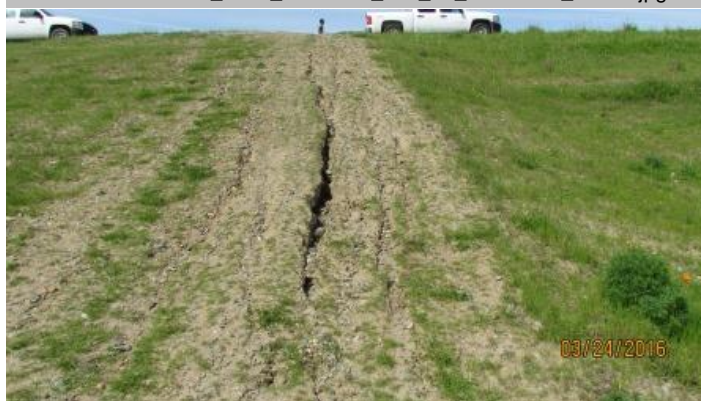
Photo 1 of 2 : FA\_2016\_LD0001S\_433\_42\_20160906\_00015.jpg

LM Start	11.63	Rating **	M	Issue No.	42
LM End	11.63	Issue Type +	Ma	Location *	WS
Category	Earthen Levee			GPS Latitude/Longitude	
				Start	End
Item	Slope Stability			39.109692 °	39.109692 °
				-121.607142 °	-121.607142 °
DWR ID	DWR_LD0001S_01_s_2016_42				
Comment Code					
S1 : Repair slope instability.					
Inspector Comment					
Erosion on the waterside slope caused by rain and foot traffic needs to be monitored. Fall 2016.

Slope erosion due to rain on the waterside. Spring 2016.

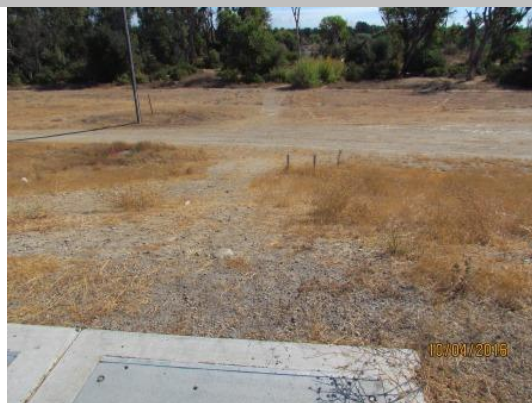
Photo 2 of 2 : FA\_2016\_LD0001S\_433\_42\_20161007\_00081.jpg

View of where slope erosion due has occurred due to rain and foot traffic on the waterside. Fall 2016.

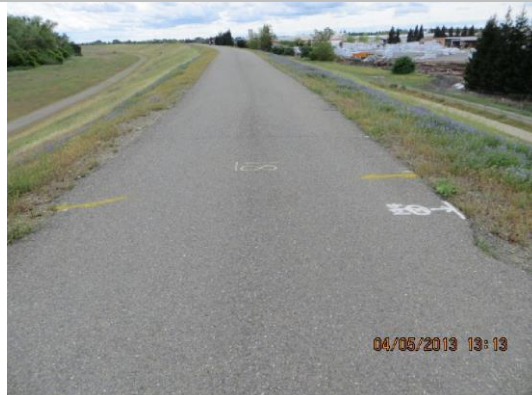
Photo 1 of 2 : UCIP\_FA\_2016\_41841\_19538.jpg

FS\_ID:41841  
DS\_ID:17932  
EP\_NO: N/A  
Repair Type: Non-Urgent  
Crossing Status: Indicator Found  
UCIP Comments: Need to install Gasline Markers.Fenced control station.Indicator on LS across concrete ditch.Found road markings.  
FIELD\_STRUCT\_DESC: 1 of 2. One 16-inch pipe of two 16-inch gas lines through levee, 3 feet below crown. PG&E gas line-crossing sign on waterward shoulder.  
FS Date: 4/5/2013

Levee Crown: gasline indicator/markings on crown road.

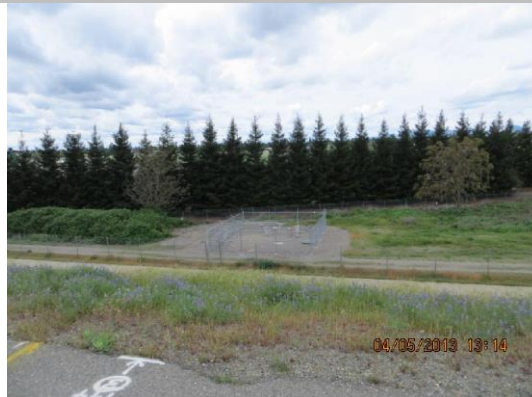
Photo 2 of 2 : UCIP\_FA\_2016\_41841\_19537.jpg

LS- fenced control station across concrete ditch

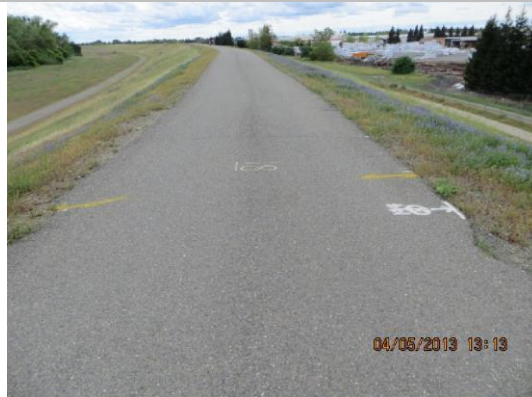
Photo 1 of 2 : UCIP\_FA\_2016\_41889\_19566.jpg

LM Start	12.00	Rating **	M	Issue No.	496
LM End	12.00	Issue Type +	En	Location *	WS
Category	Supplemental			GPS Latitude/Longitude	
				Start	End
Item	DWR UCIP Field Study			39.114856 °	39.114856 °
				-121.605821 °	-121.605821 °
DWR ID					
Comment Code					
Inspector Comment					
FS_ID:41889					
DS_ID:18880					
EP_NO: N/A					
Repair Type: Non-Urgent					
Crossing Status: Indicator Found					
UCIP Comments: Need to contact owner to install gasoline markers.Fenced control station on LS.Indicator on LS across concrete channel.Road markings.					
FIELD_STRUCT_DESC: 2 of 2. One 16-inch pipe of two 16-inch gas lines through levee, 3 feet below crown. PG&E gas line-crossing sign on waterward shoulder.					
FS Date: 4/5/2013

Levee Crown: road markings on road pavement

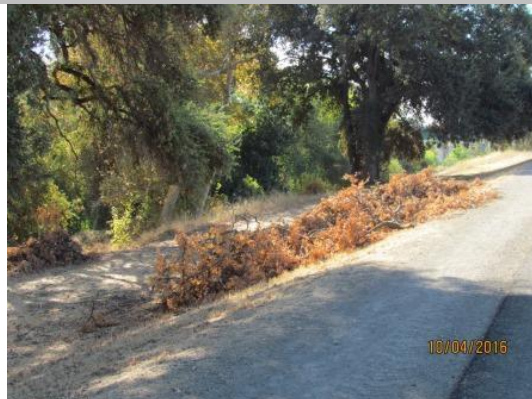
Photo 1 of 1 : FA\_2016\_LD0001S\_433\_32\_20161007\_00064.jpg

View of pruning's on the waterside slope looking downstream. Fall 2016.

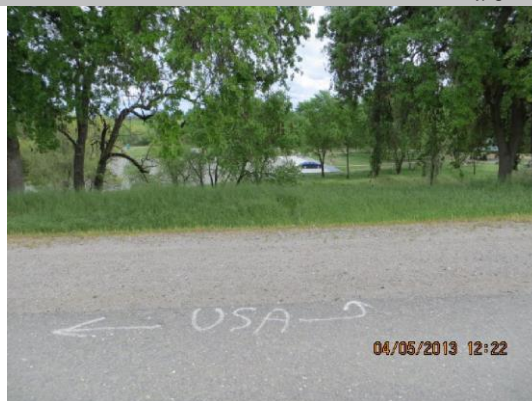
Photo 1 of 2 : UCIP\_FA\_2016\_41887\_19571.jpg

LM Start	14.35	Rating **	M	Issue No.	494
LM End	14.35	Issue Type +	En	Location *	WS
Category	Supplemental			GPS Latitude/Longitude	
				Start	End
Item	DWR UCIP Field Study			39.146494 °	39.146494 °
				-121.609715 °	-121.609715 °
DWR ID					
Comment Code					
Inspector Comment					
FS_ID:41887 DS_ID:18640 EP_NO: N/A Repair Type: Non-Urgent Crossing Status: Indicator Found UCIP Comments: Need to contact ownder to determin status of crossing and install signs if appropriate. FIELD_STRUCT_DESC: A 18-inch steel; Gas Line. O&M Manual Sac 144, August 1955, Revision Year 2011. FS Date: 4/5/2013

WS- USA road marking and floodway area

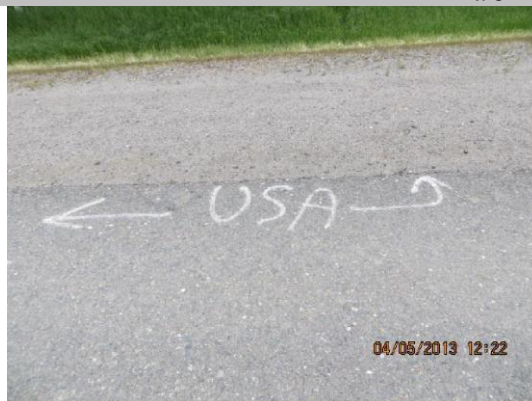
Photo 2 of 2 : UCIP\_FA\_2016\_41887\_19570.jpg

WS- USA road marking on pavement

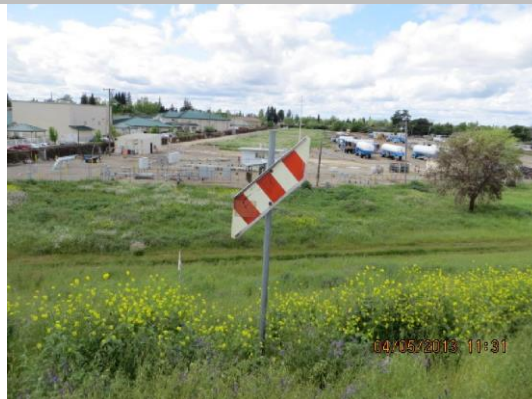
Photo 2 of 2 : UCIP\_FA\_2016\_12092\_19623.jpg

LS- gasline marker on levee slope

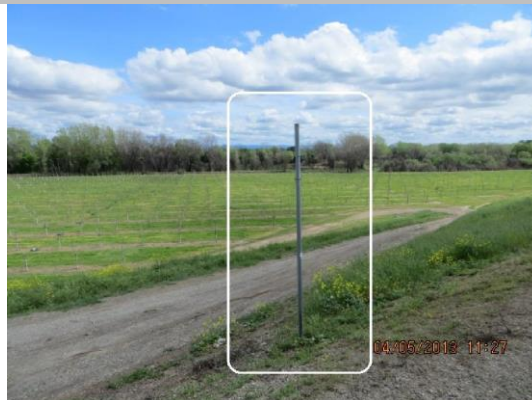
Photo 1 of 2 : UCIP\_FA\_2016\_12104\_19642.jpg

LM Start	15.15	Rating **	M	Issue No.	490
LM End	15.15	Issue Type +	En	Location *	WS
Category	Supplemental			GPS Latitude/Longitude	
				Start	End
Item	DWR UCIP Field Study			39.156241 °	39.156241 °
				-121.617210 °	-121.617210 °
DWR ID					
Comment Code					
Inspector Comment					
FS_ID:12104					
DS_ID:18644					
EP_NO: 17259					
Repair Type: Non-Urgent					
Crossing Status: Indicator Found					
UCIP Comments: Found an indicator only on LS. Needs an indicator also on WS.					
FIELD_STRUCT_DESC: An 8-3/8-inch-wide Electrolysis Test Station (ETS) at a depth of 4 feet and connect it to the existing 8-inch metal gas line within the waterside levee toe of the right (west) bank of the Feather River.					
FS Date: 4/5/2013

WS- needs a gasline indicator.

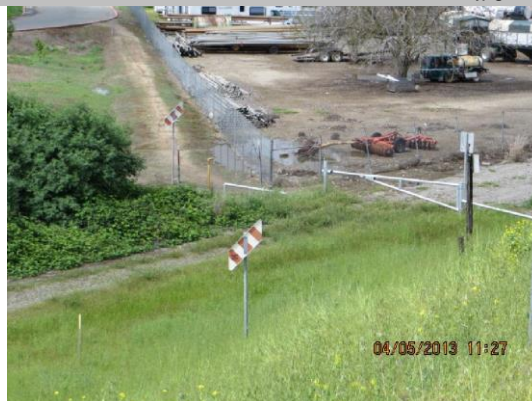
Photo 2 of 2 : UCIP\_FA\_2016\_12104\_19641.jpg

LS- gasline indicators on levee slope and across.

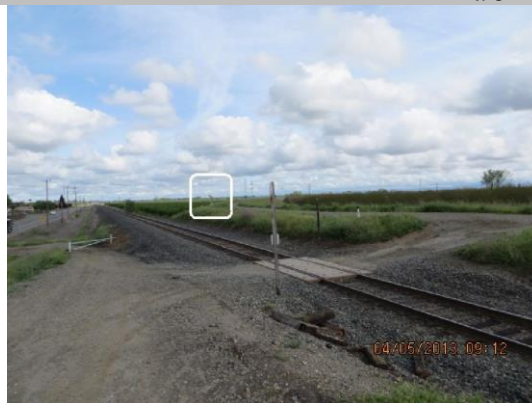
Photo 1 of 2 : UCIP\_FA\_2016\_41888\_19709.jpg

LM Start	16.11	Rating **	M	Issue No.	495
LM End	16.11	Issue Type +	En	Location *	WS
Category	Supplemental			GPS Latitude/Longitude	
				Start	End
Item	DWR UCIP Field Study			39.168830 °	39.168830 °
				-121.622628 °	-121.622628 °
DWR ID					
Comment Code					
Inspector Comment					
FS_ID:41888 DS_ID:18645 EP_NO: 3823 Repair Type: Non-Urgent Crossing Status: Indicator Found UCIP Comments: Need to contact owner to determine status of crossing and install markers if appropriate. Several lines in area. FIELD_STRUCT_DESC: A 8-inch steel gasline crossing the South Yuba River project levee, and the Yuba River overflow area. Pipe depth is 3.3 ft. below the crown. Application no. 3823, 1961. FS Date: 4/5/2013

Railway and levee crossing and gasline sign across the railway

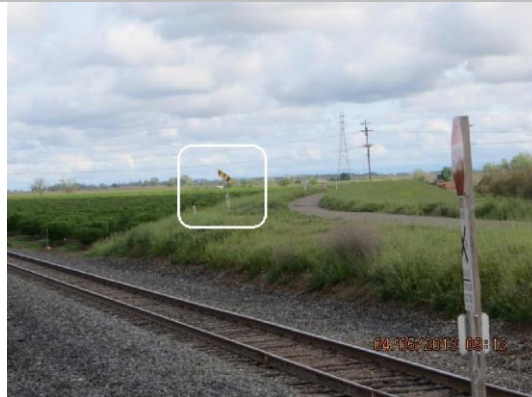
Photo 2 of 2 : UCIP\_FA\_2016\_41888\_19708.jpg

Gasline sign across the railway
